# NATIONAL TRANSPORTATION SAFETY BOARD

## PIPELINE ACCIDENT REPORT

NATURAL GAS EXPLOSION AND FIRE  
DEPARTMENT OF DEFENSE/ARMY  
FORT BENJAMIN HARRISON  
INDIANAPOLIS, INDIANA  
DECEMBER 9, 1990

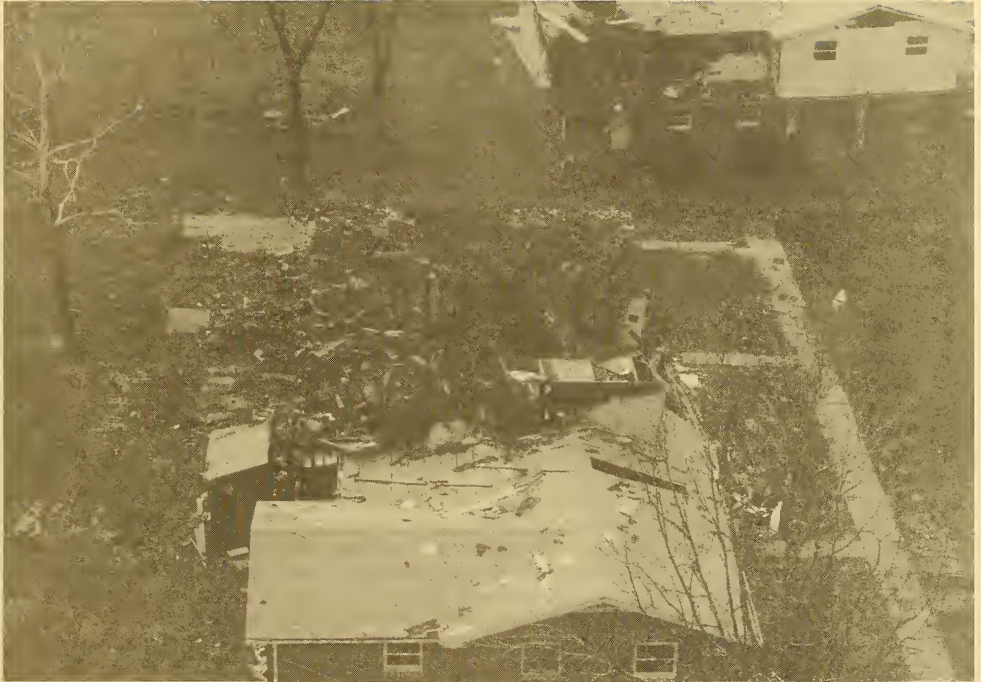
Figure 2.--View of the destroyed and damaged buildings.

The Army Corps of Engineers (Corps) estimated the explosion and fire damages to buildings 1023 and 1024 at \$3,800 and \$48,500, respectively. Building 1025 was destroyed, and the estimated loss was \$300,000. Total building damage was approximately \$352,000. After the accident, the gas company replaced the entire village gas distribution system at a cost of \$147,000 to the Army. Also, flexible gas fuel piping and vent pipes within the village were replaced at a cost of \$73,000.

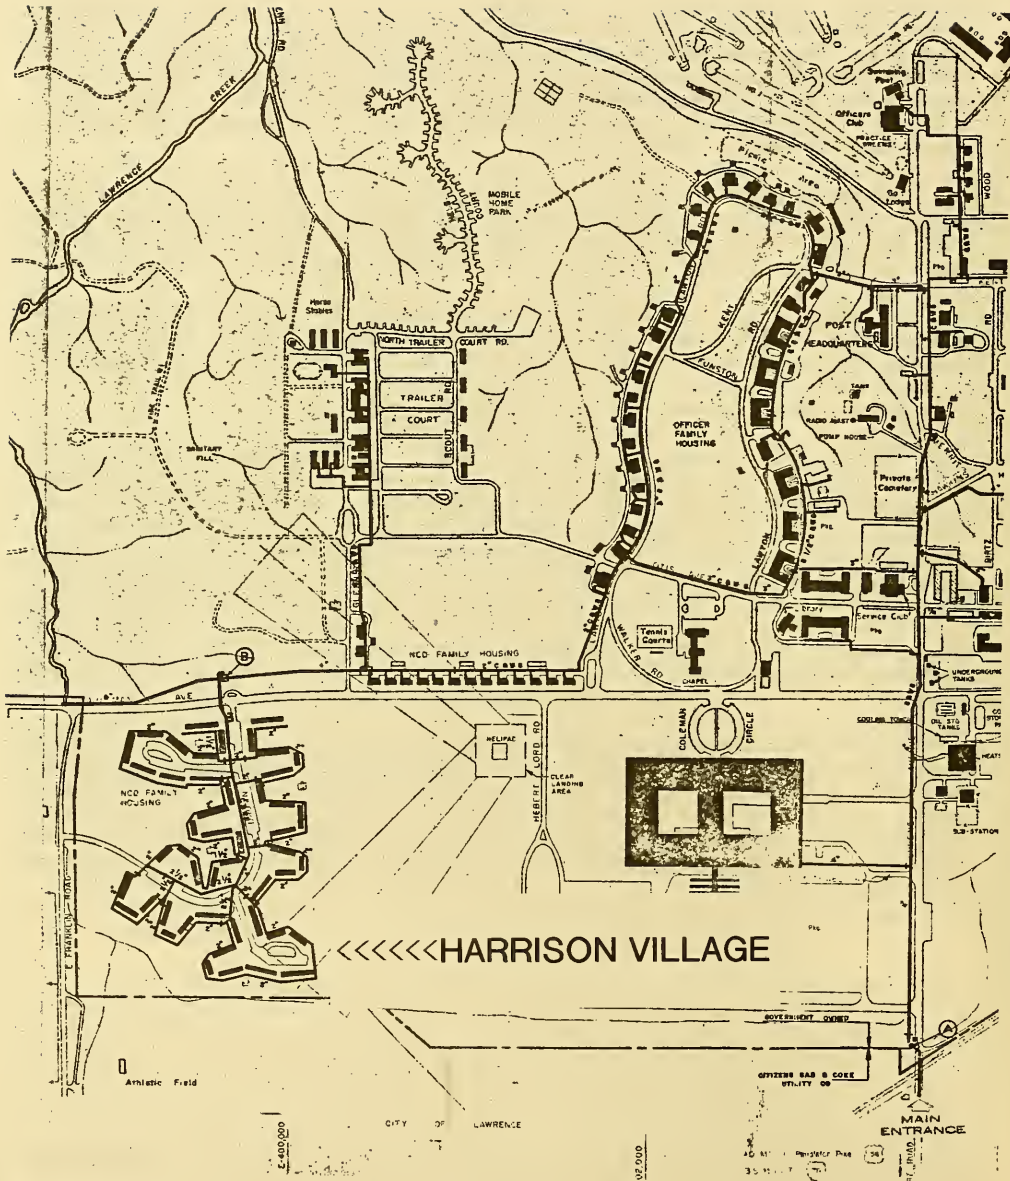
When the engineer returned with the map from the plumbing shop, he and the incident commander found that the scale of the map was too large (1 inch to 800 feet) and did not show the locations of all gas valves. (See figure 3.) The incident commander then ordered the engineer to shut off the gas supply to the village.

Figure 3.--Harrison Village as shown on the 1982 map brought by the night duty engineer to the village.

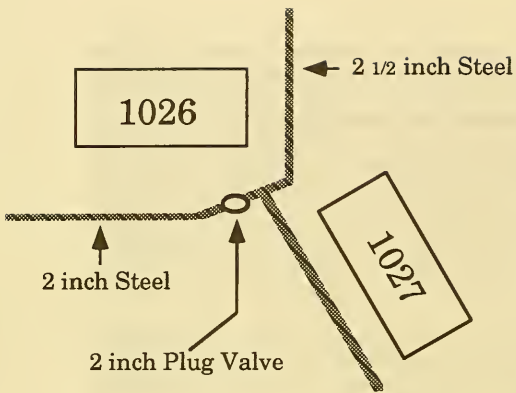
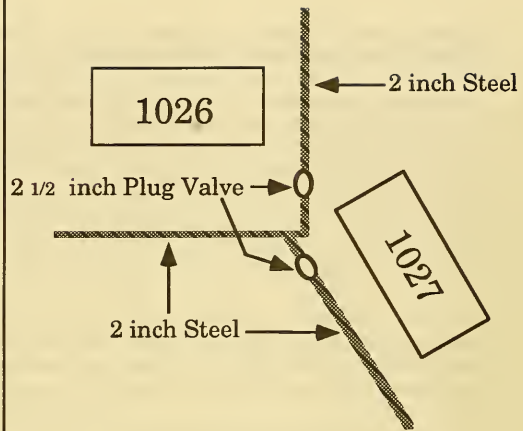
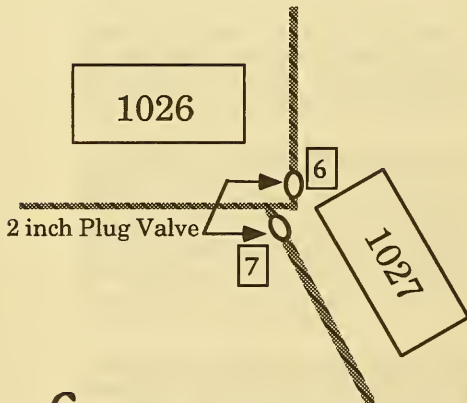
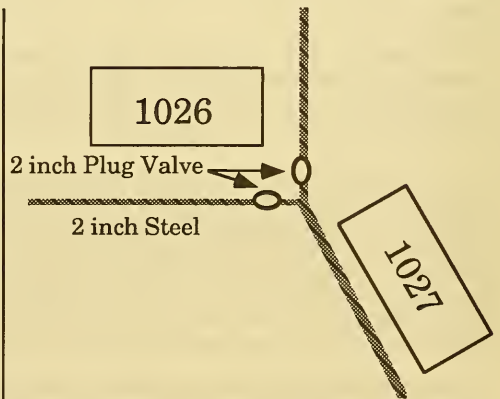
An approved-for-construction drawing dated 1971 did not show the valve behind building 1027 but did show the valves beside and behind building 1026. (See figure 4D.) This drawing also did not show the distance between the buildings and the gas mains.

D. 1971 Approved for  
Construction DrawingFigure 4.--Valve arrangement between buildings 1026 and 1027  
as shown on various Fort documents.

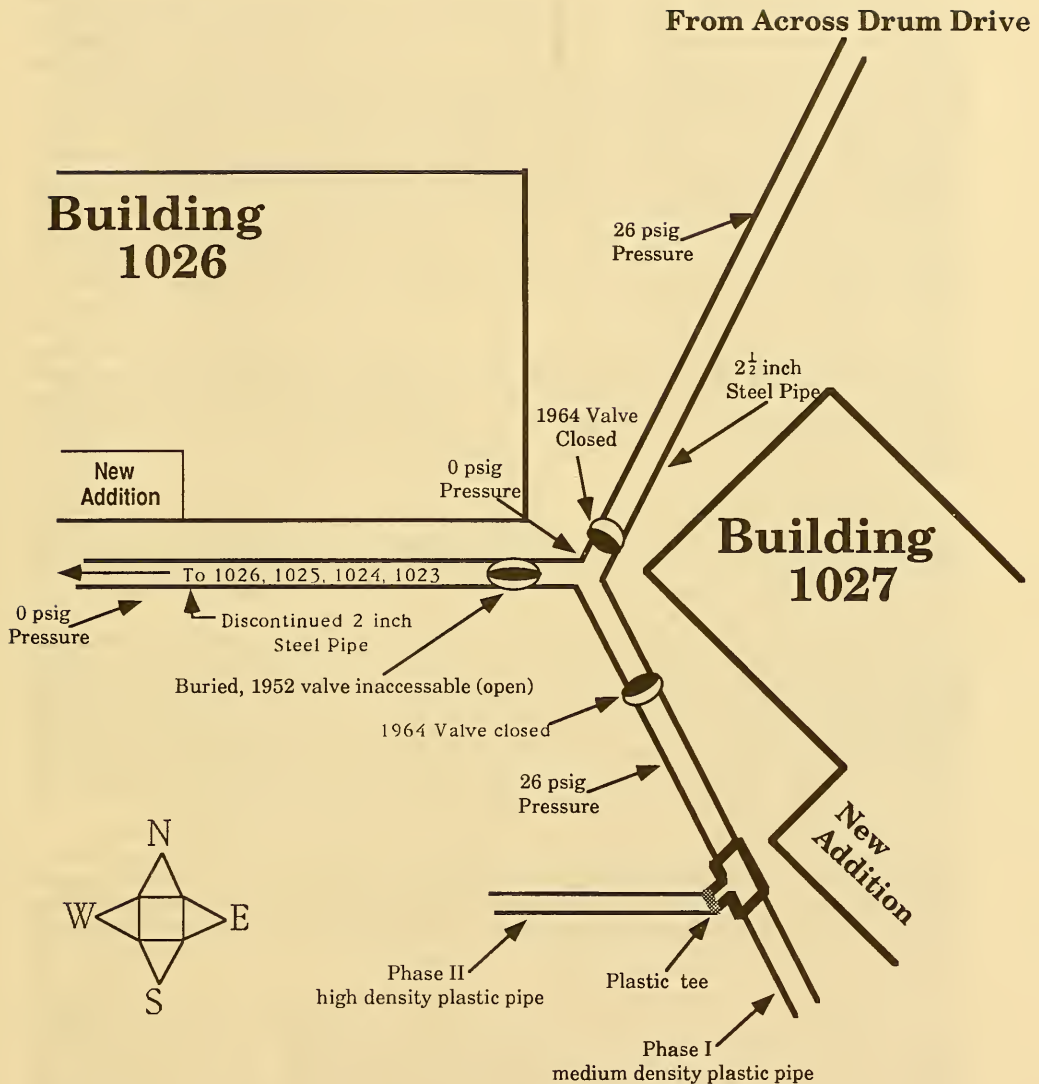
The contractor's as-built drawing showed that some of the old steel piping loop between buildings 1027 and 1035 remained. The drawing also indicated that two new valves had been installed during Phase II to replace valves abandoned between buildings 1027 and 1028 and between buildings 1033 and 1034 in that nine-building loop. The steel piping not replaced in the loop was not pressure tested or otherwise checked for leaks, and its corrosion protection system was not tested to determine whether the anodes had remained in electrical contact during the construction and whether the electrical protection was adequate to prevent corrosion.

Figure 5.--Schematic showing the gas pipes and valves near buildings 1026 and 1027 as found after the accident.
